HARFORD COUNTY DPW

UPPER FARNANDIS SMALL WATERSHED ASSESSMENT REPORT

APRIL 02, 2018

HARFORD COUNTY DEPARTMENT OF
PUBLIC WORKS

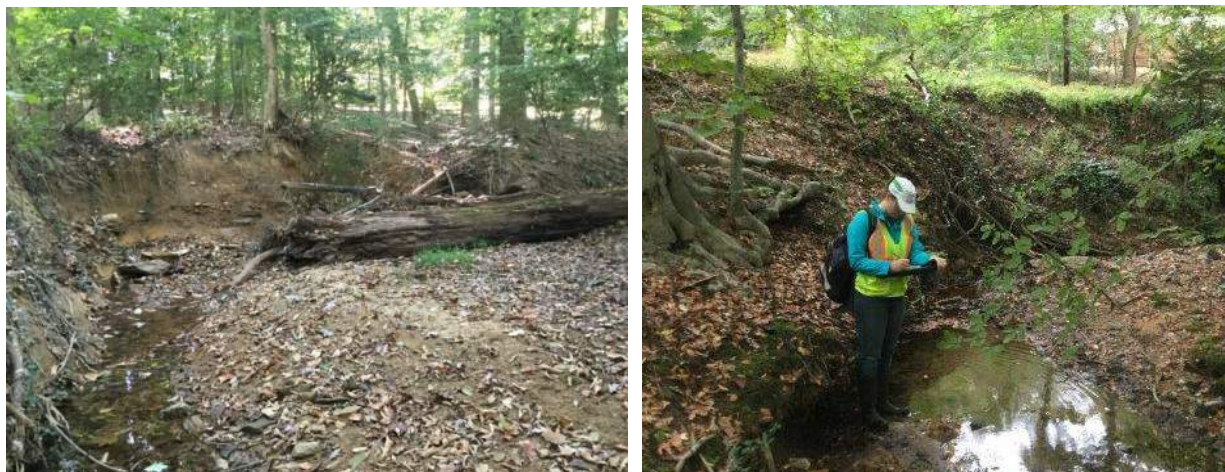
Figure 4-13 shows an example of two very severe erosion site. The figure on the left is of site D2-ES-04, a very severe erosion site with six to nine-foot vertical bank heights over a 650-foot distance. The figure on the right is of site C2-ES-15, a very severe erosion site in Fairmont with nine-foot vertical bank heights over a 70-foot distance. The edge of pavement on Victory Road can be seen from the stream channel. Both erosion sites are widening. The location of all erosion sites can be seen in Figure 4-14.

Figure 4-13: Example of a Very Severe Erosion Site in Fairmont (Left) and a Very Severe Erosion Site in Victory (Right)

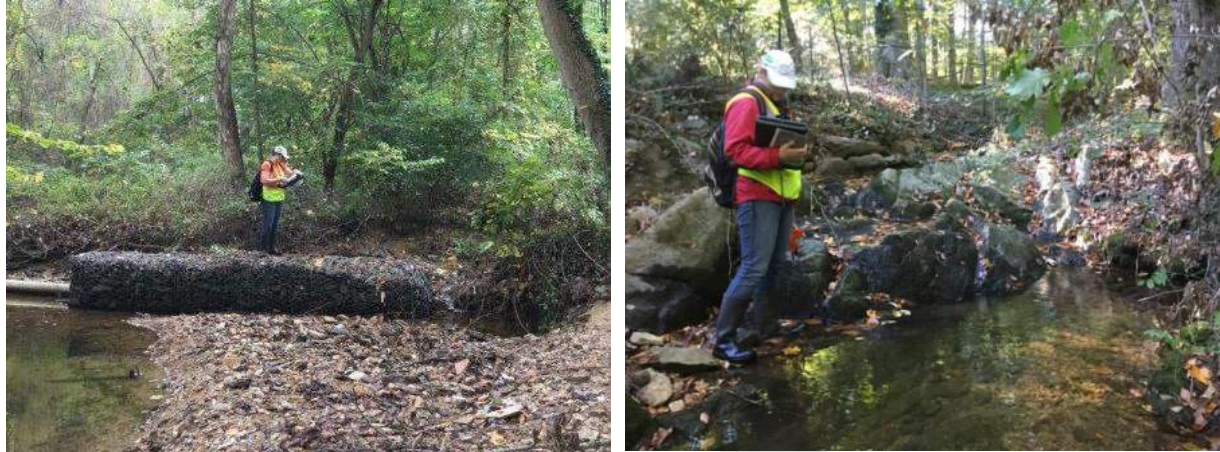
Figure 4-15 shows two moderate fish barriers where the drop between the culvert and the natural channel is too high for the fish to pass and/or too shallow. In all cases, the location of the fish barrier within the subwatershed has an impact on the severity rating.

Figure 4-15: Example of a Moderate Fish Barrier where a Gabion Basket Blocks a Tributary to the Main Stem (Left) and Moderate Bedrock Fish Barrier (Right)

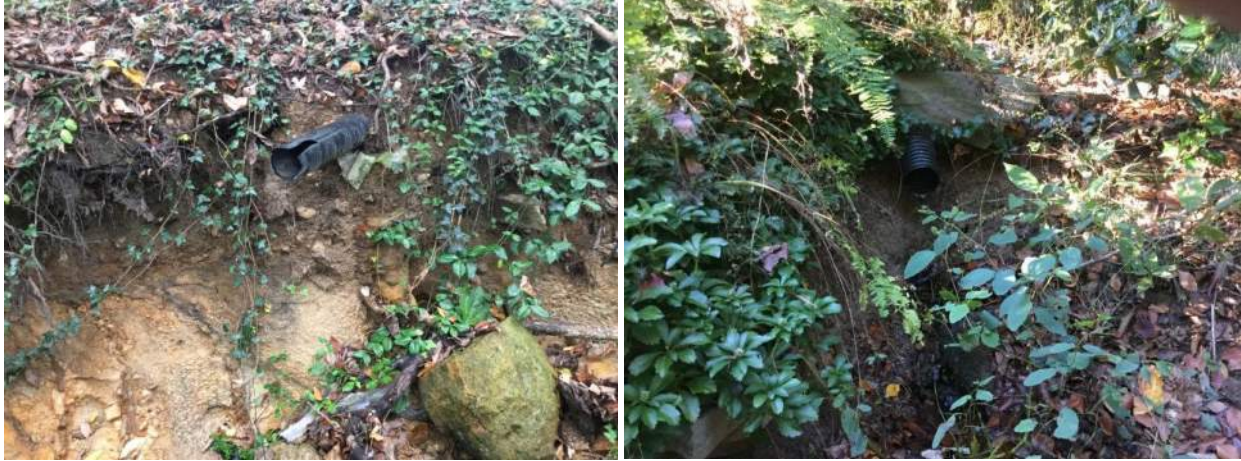
Pipe outfalls include pipes or small manmade channels that discharge into the stream. They are considered a potential environmental problem because they can carry uncontrolled runoff and pollutants such as oil, heavy metals, and nutrients into a stream system. Pipe outfalls can also create significant erosion problems as high flows without proper velocity dissipation can lead to extensive erosion and scour in the receiving channel; separate erosion sites were also documented if necessary at pipe outfall locations. The severity rating for a pipe outfall was primarily based on the discharge including whether discharge was present, color, odor, amount, and downstream impacts (not including erosion, which was assessed separately). A total of 20 pipe outfalls were surveyed during the SCAs in Upper Farnandis (Table 4-13). The highest severity rating for pipe outfalls was minor, shown in Figure 4-16.

Figure 4-16: Minor Pipe Outfalls

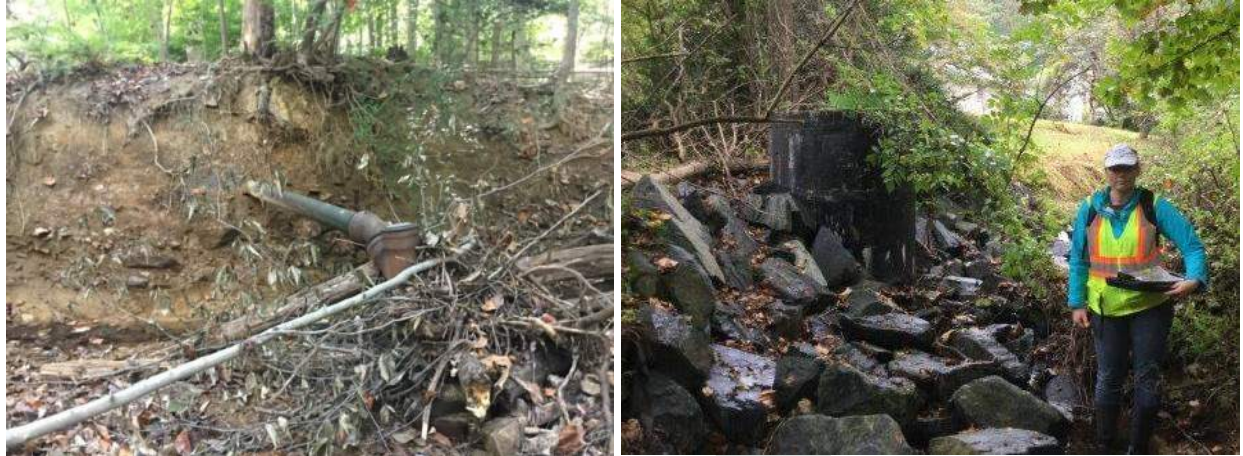
Subwatershed	SEVERITY RATING					Total
	Very Severe	Minor				
	1	2	3	4	5	
Brook Hill	0	1	1	0	0	2
Fairmont	1	1	0	0	0	2
Grosvenor	0	0	0	0	0	0
Macphail	0	0	0	0	0	0
Ring Factory	0	0	0	1	0	1
Victory	1	1	0	0	0	2
Total	2	3	1	1	0	7

Figure 4-17: Exposed Pipes in the Fairmont (left) and Victory (right) subwatersheds

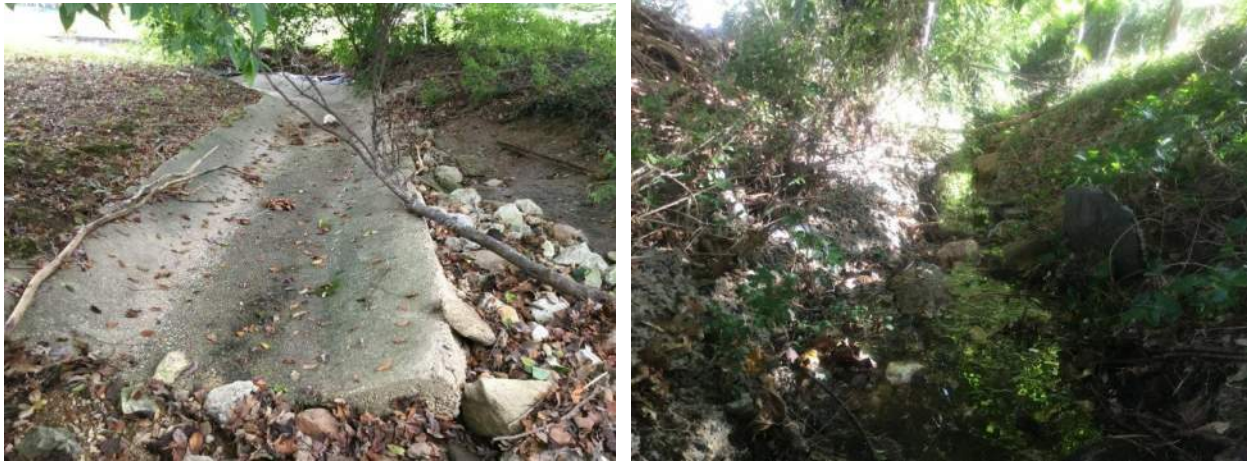
A total of 13 channel alteration sites were documented during the survey for a total length of 904 feet or 5.1% of the entire stream lengths surveyed. Severe channel alterations were the highest ranking for the Upper Farnandis watershed. The remaining sites inventoried for channel alterations, ranked either low severity or minor. A series of channel alterations were professionally designed to protect several private properties using imbricated rock walls. One severe channel alteration involves a concrete channel where sediment has filled the entrance to the concrete channel and defined a new earthen channel to the right of the concrete channel (Figure 4-18, left). A common type of channel alteration observed throughout the Upper Farnandis watershed was grouted stone placed along the channel and

banks for stabilization (Figure 4-18, right). Several channel alteration sections identified in the Upper Farnandis watershed consist of longer stream lengths and may represent an opportunity for water quality improvements. Many channel alterations are expensive and challenging to correct.

Figure 4-18: Examples of two severe Channel Alterations to convey flow under a roadway (Left) or by hardening the channel (Right)

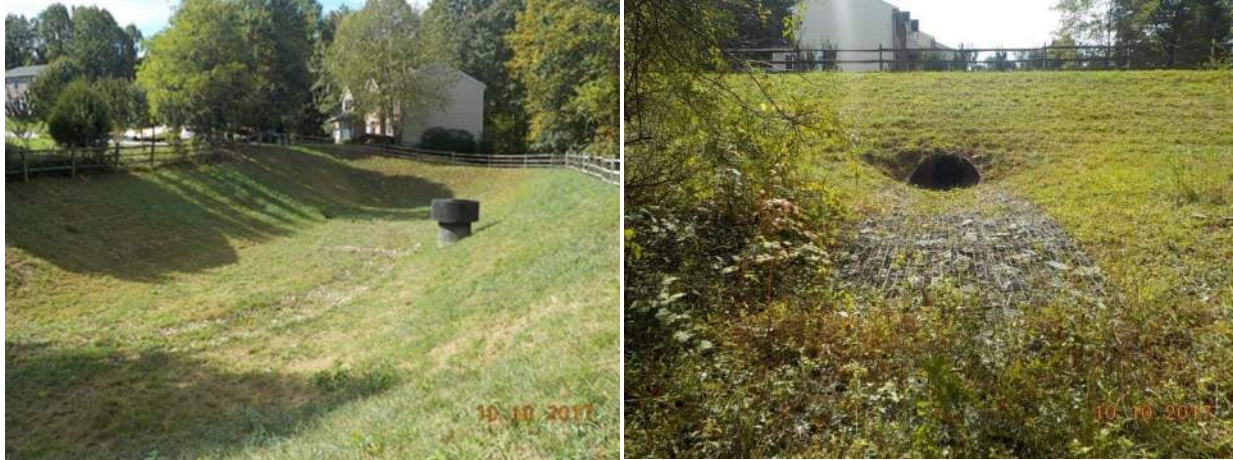
Existing BMP 2 is located at the Northern end of Brook Hill Court within the Brook Hill subwatershed (Figure 6-1, left). One 18" and one 15" pipe convey flow from the surrounding neighborhood, including most Brook Hill Court, to the existing extended detention facility. The impervious area that drains to the existing BMP accounts for 36% of the drainage area. The two pipes outfall into a pilot channel within the BMP footprint. Flow from the extended detention basin outfalls via a metal riser structure with a 30" corrugated metal pipe to gabion outfall protection before entering the perennial tributary (Figure 1, right). This metal riser serves as the emergency spillway for the facility. The facility is in good condition, with no erosion or sediment build up present.

No flow was observed to the facility. Rain had been observed in the area one day prior to the site visit. There was no standing water in the facility. The extended detention facility is being recommended as a retrofit opportunity.

Figure 6-1: Looking West to existing extended detention facility (left); Looking South at gabion outfall protection and towards existing BMP (right)

- A wet pond retrofit is recommended to target improved water quality for flow exiting the facility into the perennial stream. Permanent pools excavated down from the existing dry pond bottom are to be created to improve water quality.
- A forebay can be placed at the outfall of each pipe to slow flow entering the facility and reduce sediment loadings.
- Proposed retrofit plans are shown in Figure 6-2.

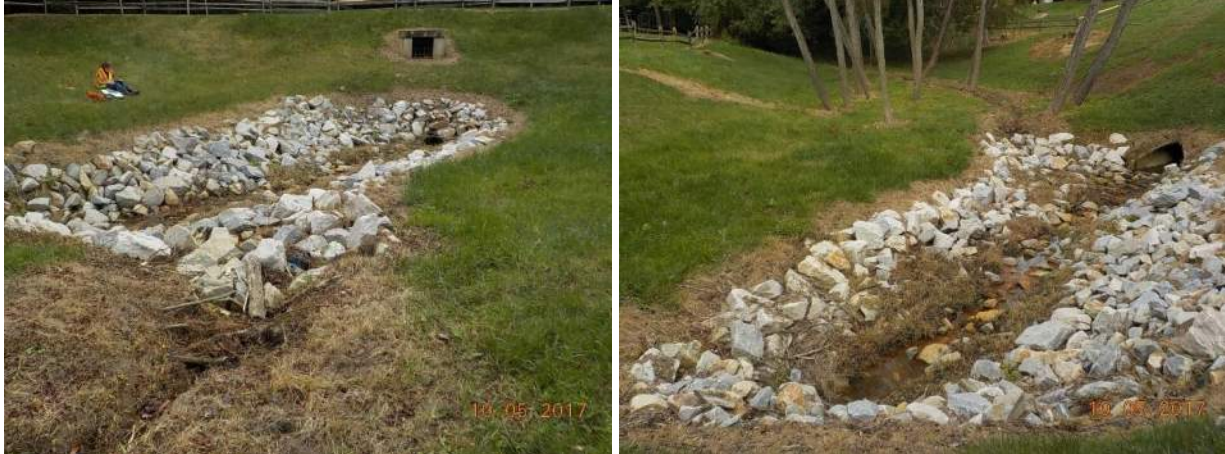
No flow was observed to the facility. Rain had been observed in the area within 3 days prior to site visit. The facility had 4" of standing water present, so water is not infiltrating. The extended detention facility is being recommended as a wet pond retrofit opportunity.

Figure 6-3: Looking Southwest to outfall structure (left); Looking Northeast to inflow to existing facility (right)

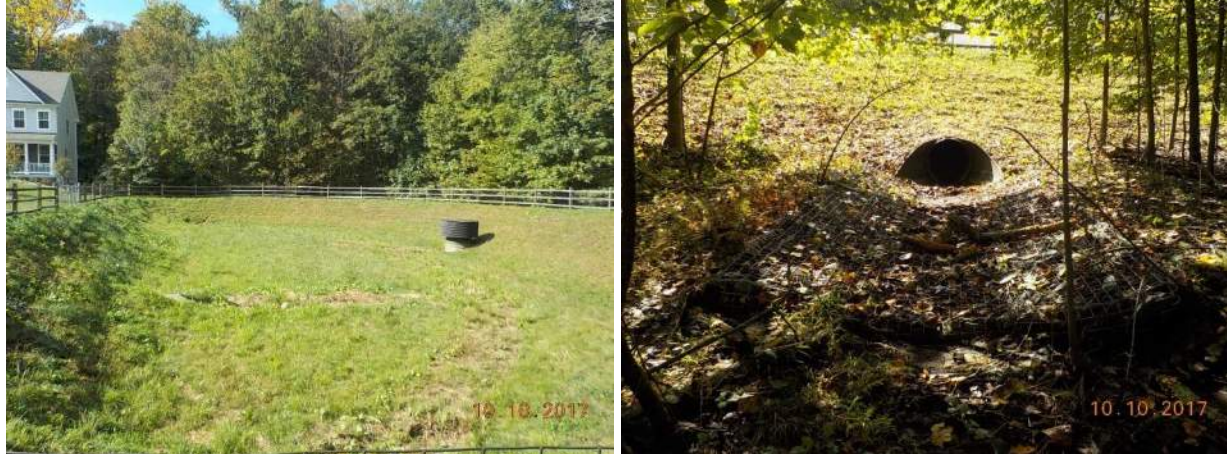
Existing BMP 4 is located at the Northern end of Raspberry Hill Court within the Brook Hill subwatershed (Figure 6-5, left). One 18" and two 12" pipes convey flow from the surrounding neighborhood, including most of Raspberry Hill Court, to the existing extended detention facility. The impervious area that drains to the existing BMP accounts for 28% of the drainage area. The three pipes outfall into pilot channels within the BMP footprint. Flow from the extended detention facility outfalls via a metal riser structure with a 30" corrugated metal pipe to gabion outfall protection (Figure 6-5, right). There is no defined channel from the gabion outfall protection to the Upper Farnandis Branch main stem. There is a 12" dewatering device below ground at the riser. The metal riser serves as the emergency spillway for the facility. The facility is in good condition, with no erosion or sediment build up present. No flow was observed to the facility and there was no standing water in the facility. Rain had been observed in the area one day prior to the site visit.

A member of the Brook Hill Manor Community Association indicated that the facility was maintained last year, during which the embankment was graded and the riser was cleaned out. This was confirmed with the person who performed the maintenance.

Figure 6-5: Looking west towards existing extended detention facility (left); Looking South to outfall pipe onto gabion outfall protection (right)

- A wet pond retrofit is recommended within the current extended detention basin footprint. The wet pond is recommended to target improved water quality for flow exiting the facility into the perennial stream. A forebay will be placed at the outfall of each pipe to dissipate the flow entering the facility and reduce sediment loadings. A permanent pool will be excavated from the existing detention basin bottom to provide water quality treatment.
- Proposed project plans are shown in Figure 6-6.

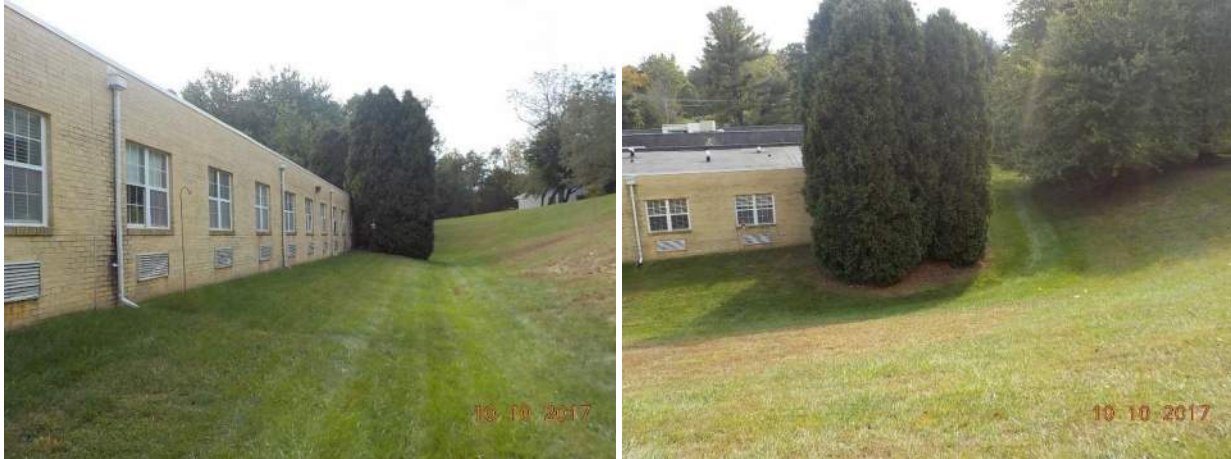
The Bel Air Health and Rehabilitation Center is located at the intersection of E Macphail Rd. and Woodbury Way within the Macphail subwatershed. Under current conditions, the rooftop drains into an existing grass swale (Figure 1) located behind the Bel Air Health and Rehabilitation Center prior to discharging into an existing stream and storm drain system. Approximately, 2.33 acres comprising of 0.22 acres of impervious area drain to the confluence of the existing grass swale and stream (Figure 2). The confluence point of the existing grass swale and stream are unstable and eroded.

Figure 6-7: Looking West to existing grass swale (left); Looking South to existing grass swale (right)

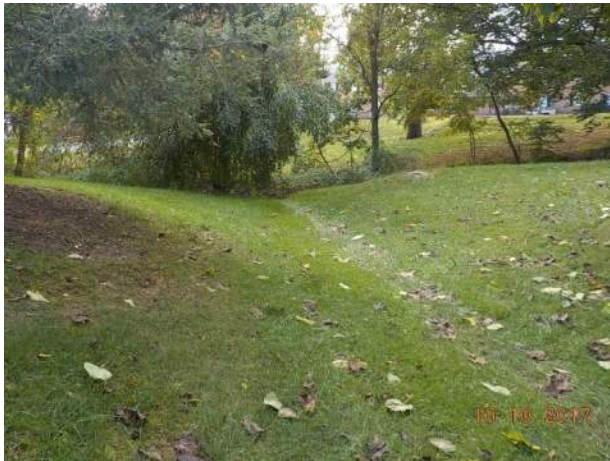
Figure 6-8: Looking South to existing grass swale prior to discharge into stream (left)

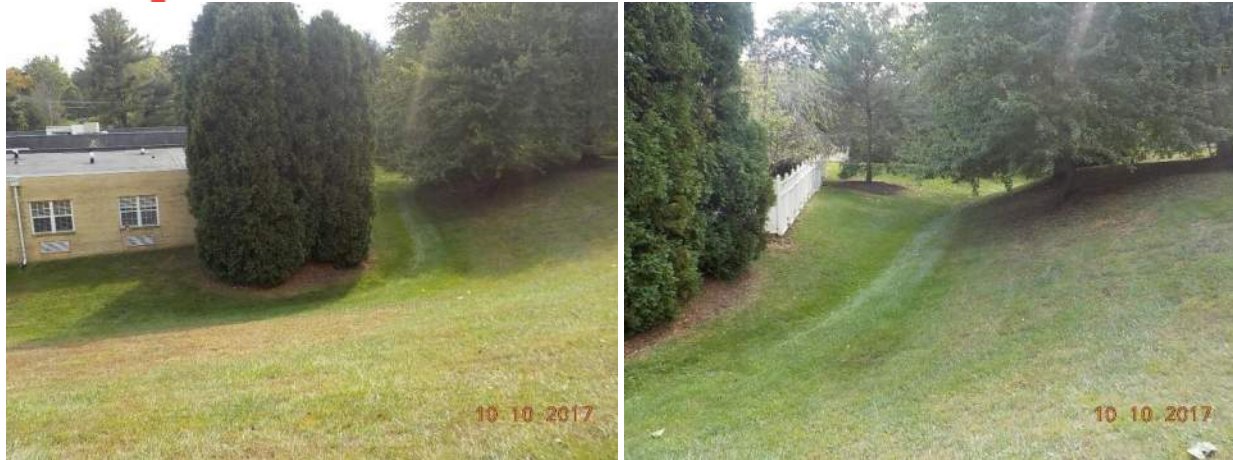
Figure 6-9: Looking South at proposed rain garden #1 location (left); Looking South to existing grass swale prior to discharge into stream (right)

- Three rain gardens are proposed adjacent to the Bel Air Health and Rehabilitation Center to treat rooftop runoff.
- Rain garden #1 (Figure 6-9, left) is proposed to be located adjacent to the back building at the downstream point of the disconnected downspouts.
- Rain garden #2 and #3 are proposed to be located adjacent to the building within the existing white fence area. Rain garden #2 and #3 (Figure 6-9, right) should be located at the downstream point of the disconnected downspouts for the applicable rooftop drainage.
- The proposed rain gardens have the potential to treat 0.22 total impervious acres.
- Proposed BMP plans are shown in Figure 6-10.

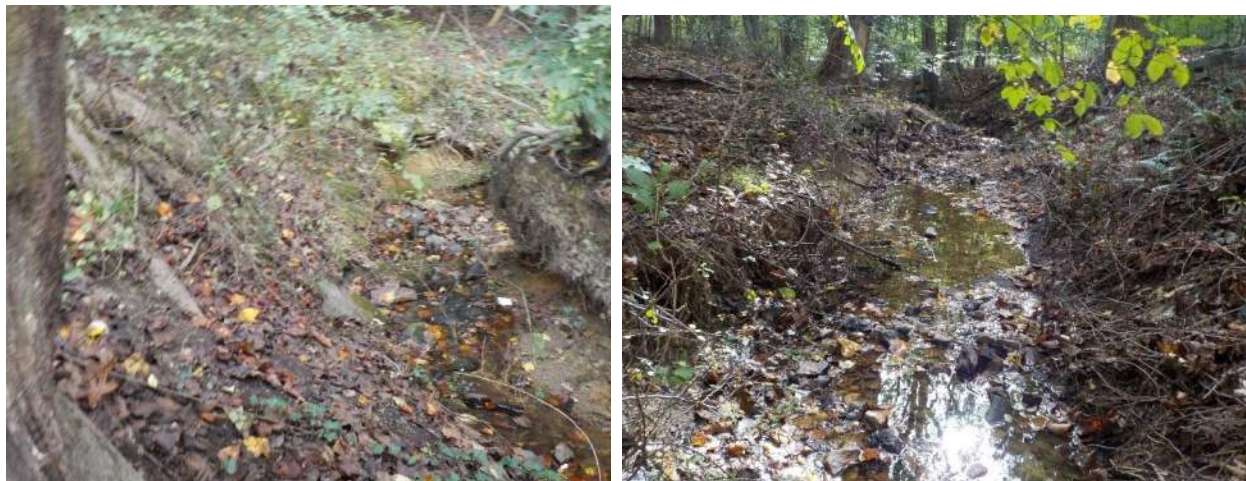
Most of tributary G-T1 is in a forested area of one HOA community. The stream through this section is 1997 feet in length and contains eroded banks ranging from 3 to 5 feet in height. G-T1 receives flow from tributary G-T2, G-T4, and three outfalls. Tributary G-T2 is part of this project site. It receives flow from G-T3 and from an extended dry detention basin, BMP-EX-03. The outfall from BMP-EX-03 was assessed as outfall 04. Outfall 04 is in good condition; however, some of the riprap outfall protection has moved downstream and is no longer protecting the outfall (Figure 6-31, left). Outfall 21 is at the headwater of G-T3 and provides flow from Charlyn Court (Figure 6-30, left). Both G-T3 and G-T2 are experiencing active erosion with 3 to 5 feet of exposed banks (Figure 6-30).

Figure 6-30: Looking downstream from Outfall 21, erosion on both banks (left); Erosion along Tributary G-T2 (right)

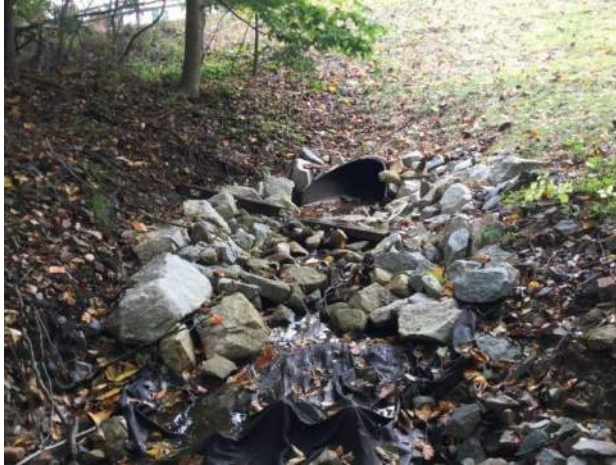
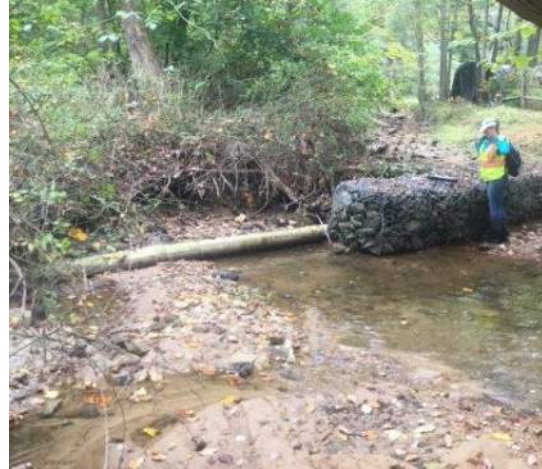
Brook Hill subwatershed begins at the confluence of G-T1 and the main stem. A gabion basket is located at the confluence of G-T1 and the main stem (Figure 6-31, right). As a result, sediment has filled in the channel of G-T1 just upstream of the gabion basket. Flow enters the main stem through a narrow channel next to the gabion basket. On the opposite side of the gabion basket, in the main stem, 16 feet of a 10" pipe has become exposed along the bottom of the stream.

The main stem is 1388 feet in length through this portion of the project site. Approximately 170 feet downstream of the confluence with G-T1, the left bank of the main stem has been hardened. At the end of Jackson Boulevard, Outfall 08 has become unstable. The pipe outfall is protruding one foot above the stream and 5 feet of the pipe is exposed (Figure 6-33, left). The left stream bank at the end of Jackson Boulevard is being held in place by two large trees. The roots are currently exposed. If these trees fall, the 7-foot left bank at Jackson Boulevard will have no protection from further erosion. From Outfall 08 to the outlet of the watershed, the main stem experiences moderate to very severe erosion with 3 to 6 foot banks. The left bank also has a very limited tree buffer (Figure 6-33, right). A sewer manhole near the outlet of the watershed is just beginning to become exposed at the top of a 7-foot bank. The outfall protection for Outfall 10 is in good condition; however, at the end of the gabion pad, the bank drops four feet to the stream bed. Further erosion along the right bank of the main stem will lead to undercutting of the gabion pad for Outfall 10. Significant erosion has occurred around outfall 31. Approximately seven feet of this 18-inch corrugated plastic pipe is exposed. The end of the pipe is laying in the stream and the slope above the right bank has caved in.

Figure 6-31: Looking upstream at displaced rip rap around Outfall 04 (left); Exposed pipe, gabion basket blocking flow from G-T1, confluence of G-T1 and main stem (right)

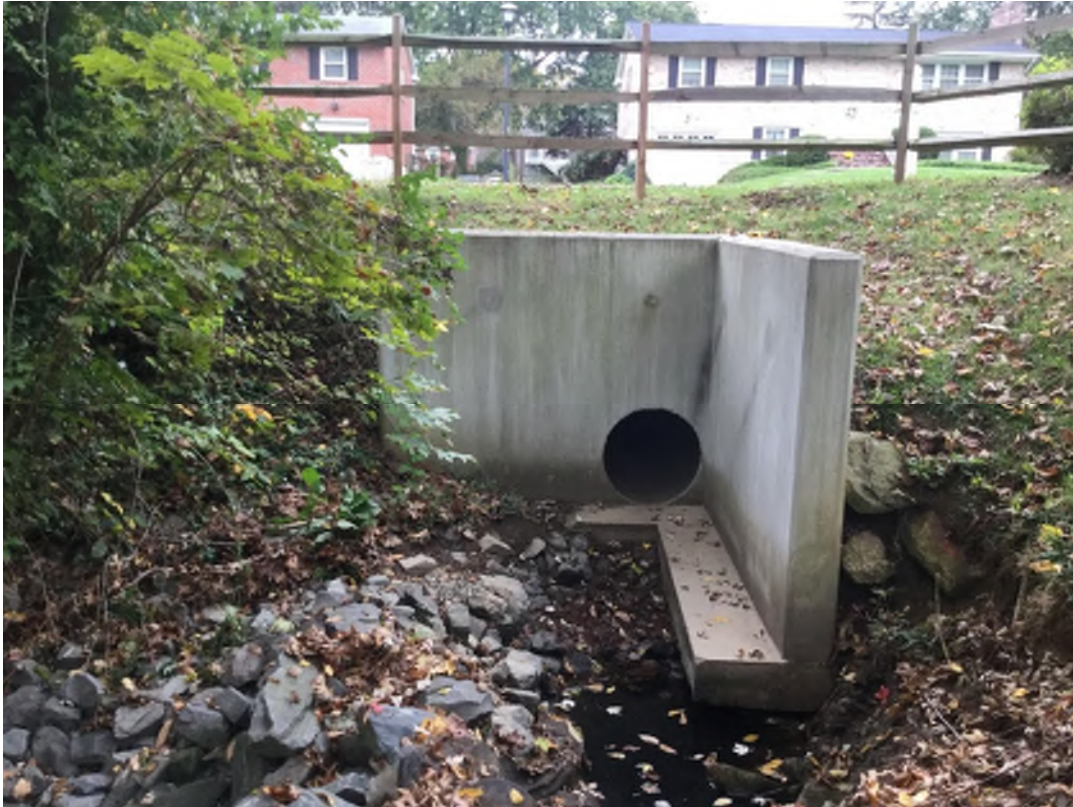
Figure 1: Outfall 1 at headwaters of tributary 2 in Macphail subwatershed

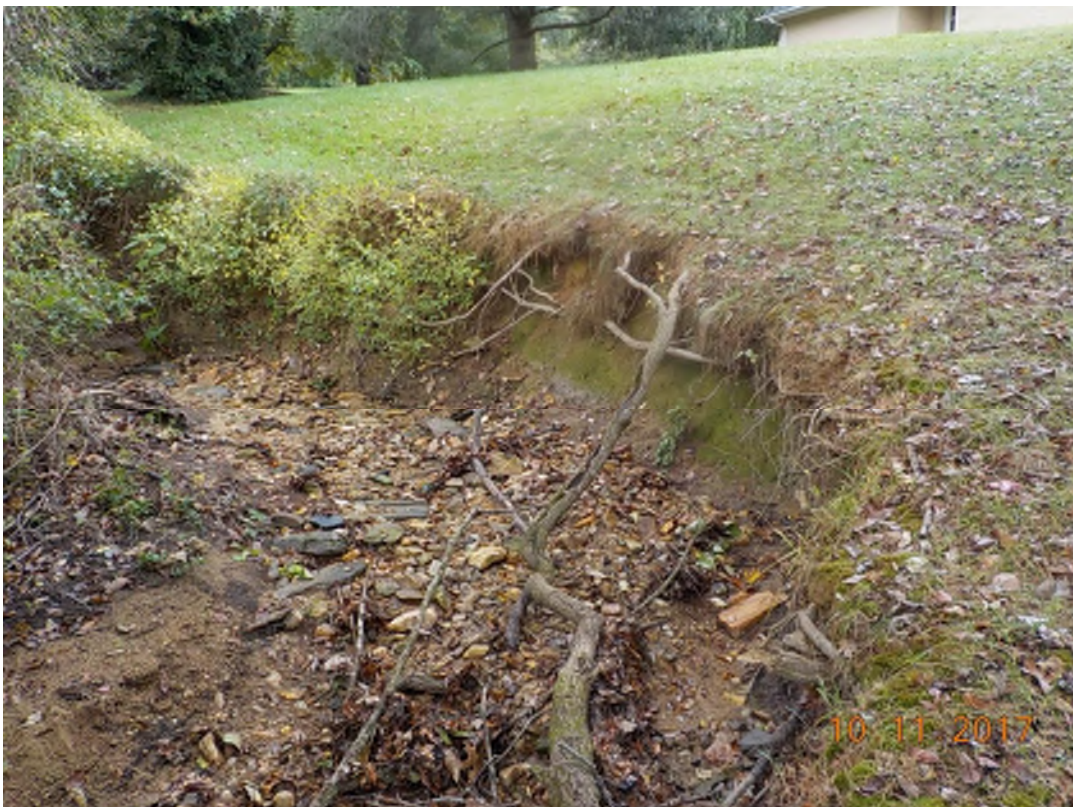
Figure 2: Erosion along tributary 2 in Macphail subwatershed

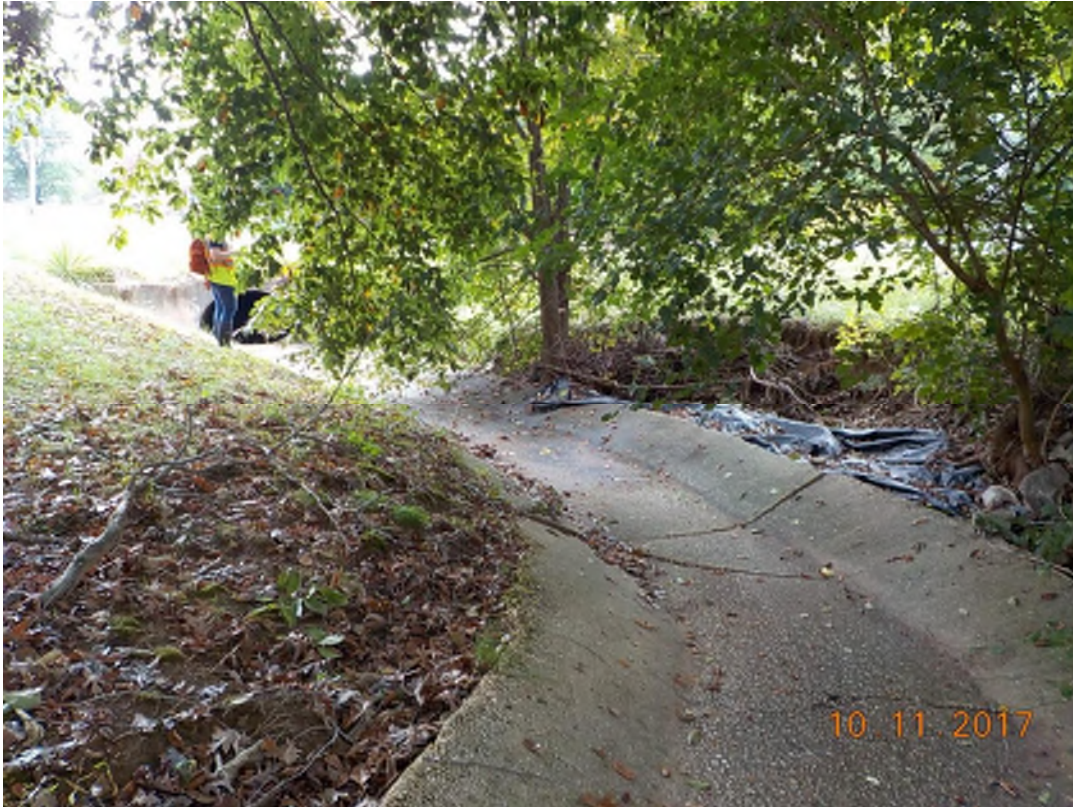
Figure 5: Concrete channel alteration placed upstream of culvert under East Macphail Road in tributary 2 of subwatershed.

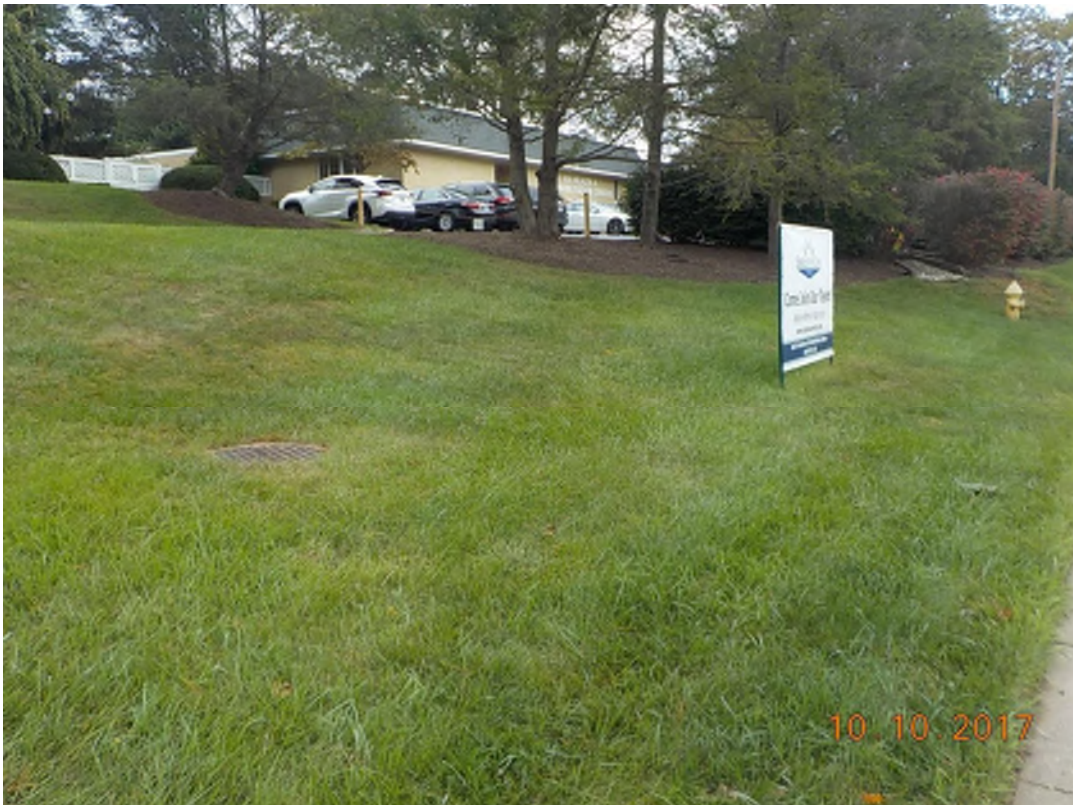
Figure 6: Existing BMP 1 is an underground dry well located adjacent to East Macphail Road. Flow is conveyed from the pictured parking lot to the existing underground facility.

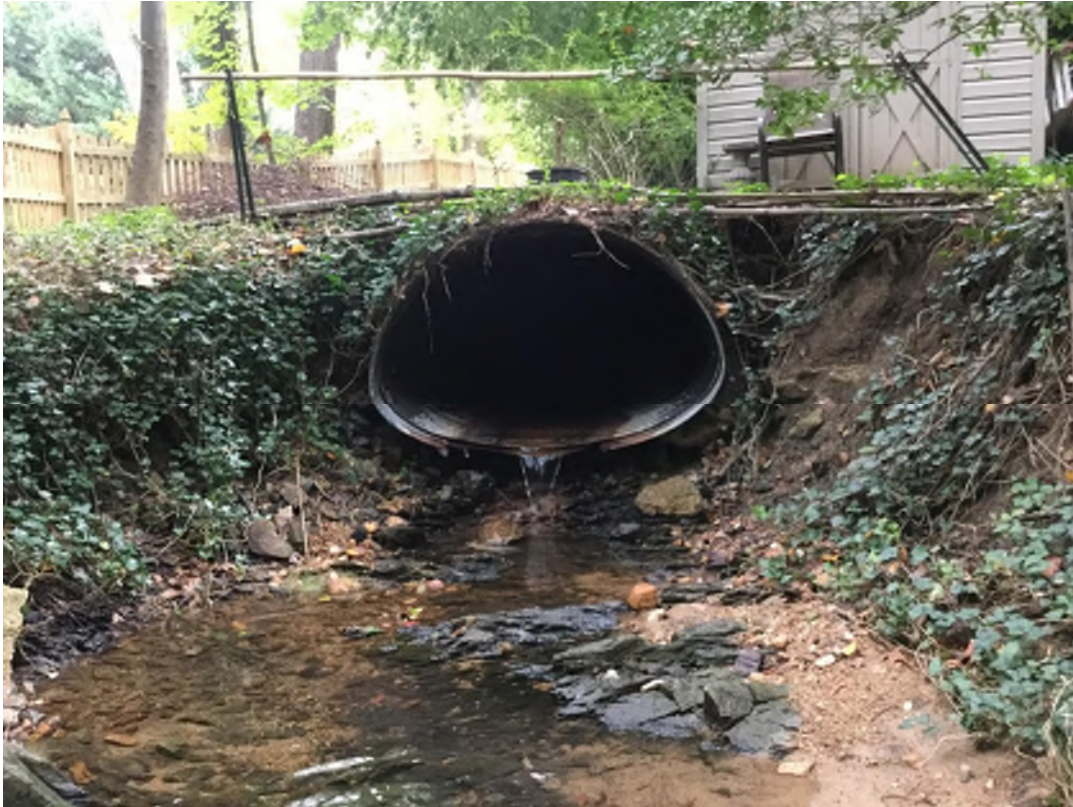
Figure 7: Outfall 14 in private property backyard conveys flow from tributary 2 North of East Macphail Road.

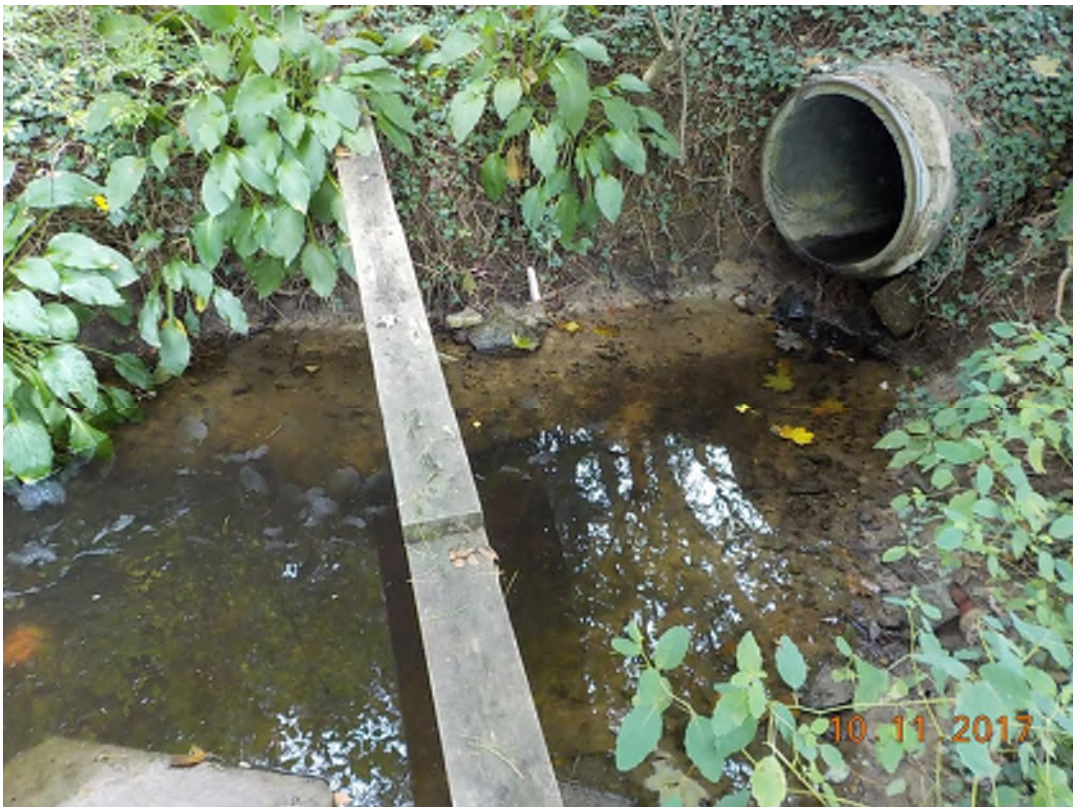
Figure 10: Concrete culvert conveys flow underground from location of outfall 20 to downstream in tributary 1. Downstream outfall pictured.

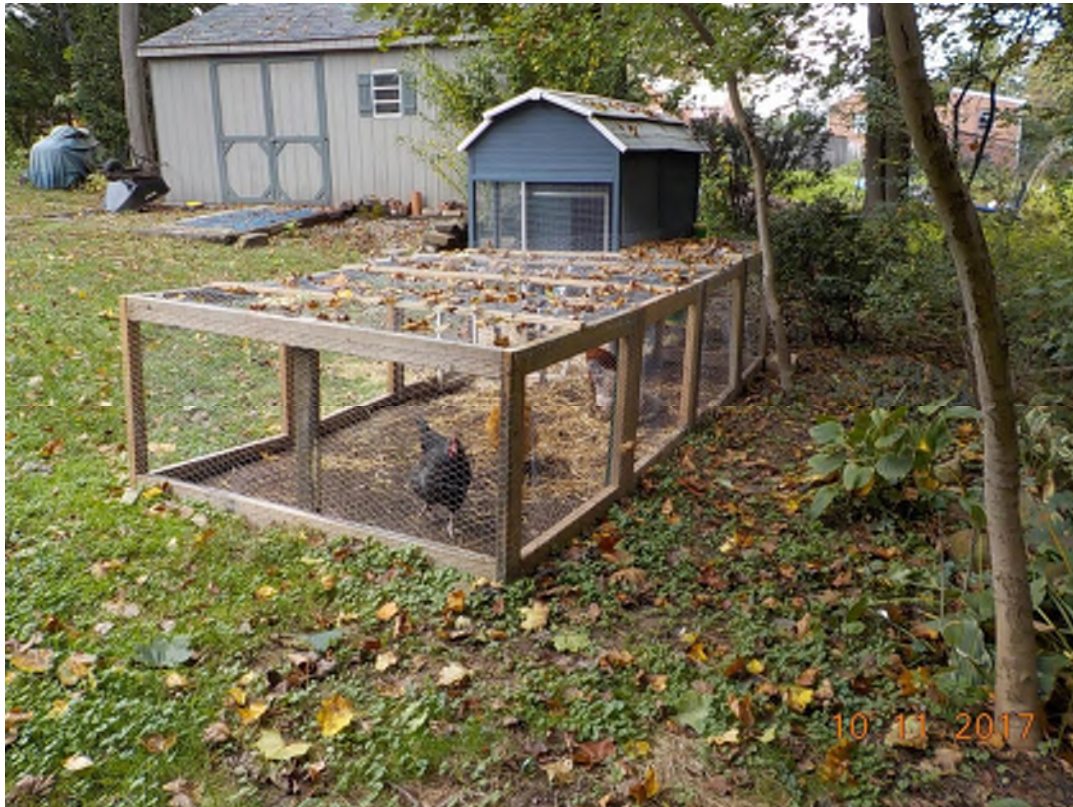
Figure 11: Chickens adjacent to tributary 1 of subwatershed.

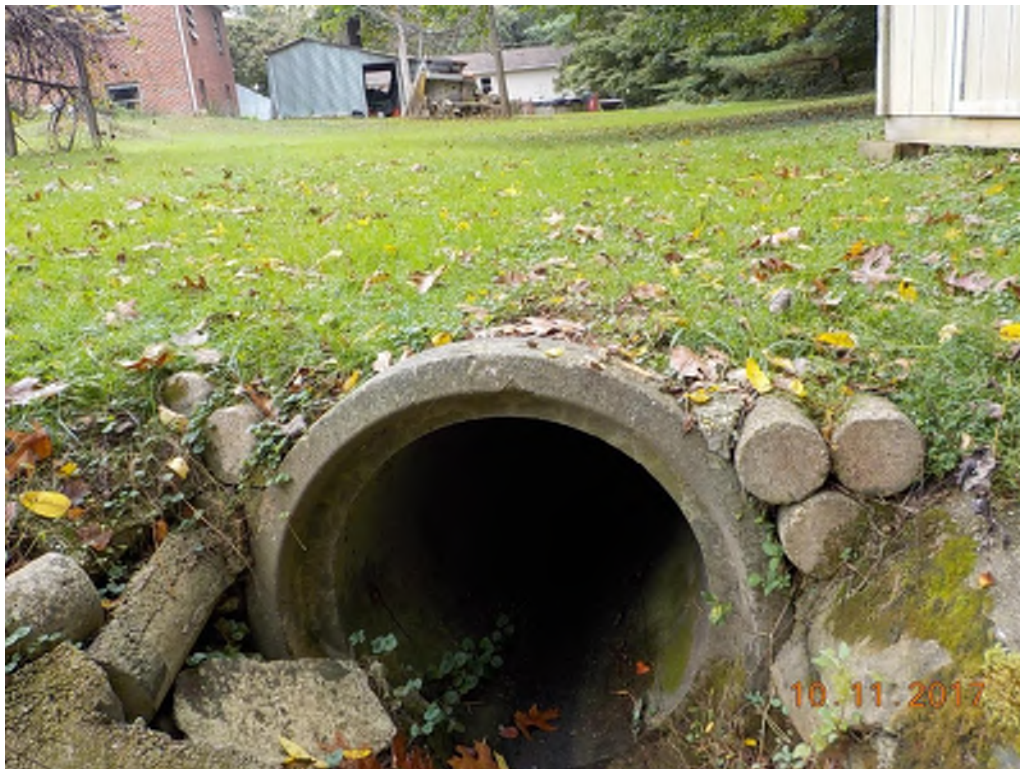
Figure 12: Concrete culvert conveys flow underground in tributary 1 of subwatershed. Upstream entrance pictured.

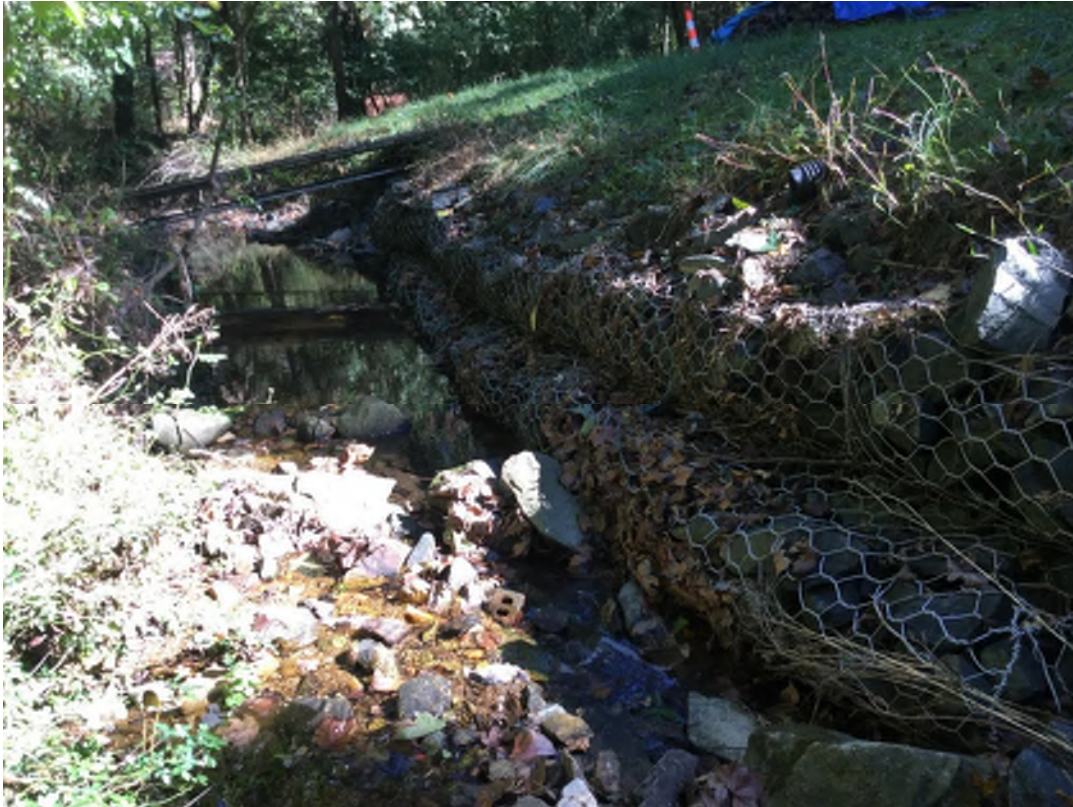
Figure 13: Gabion and wood channel alteration present in tributary 1 of subwatershed

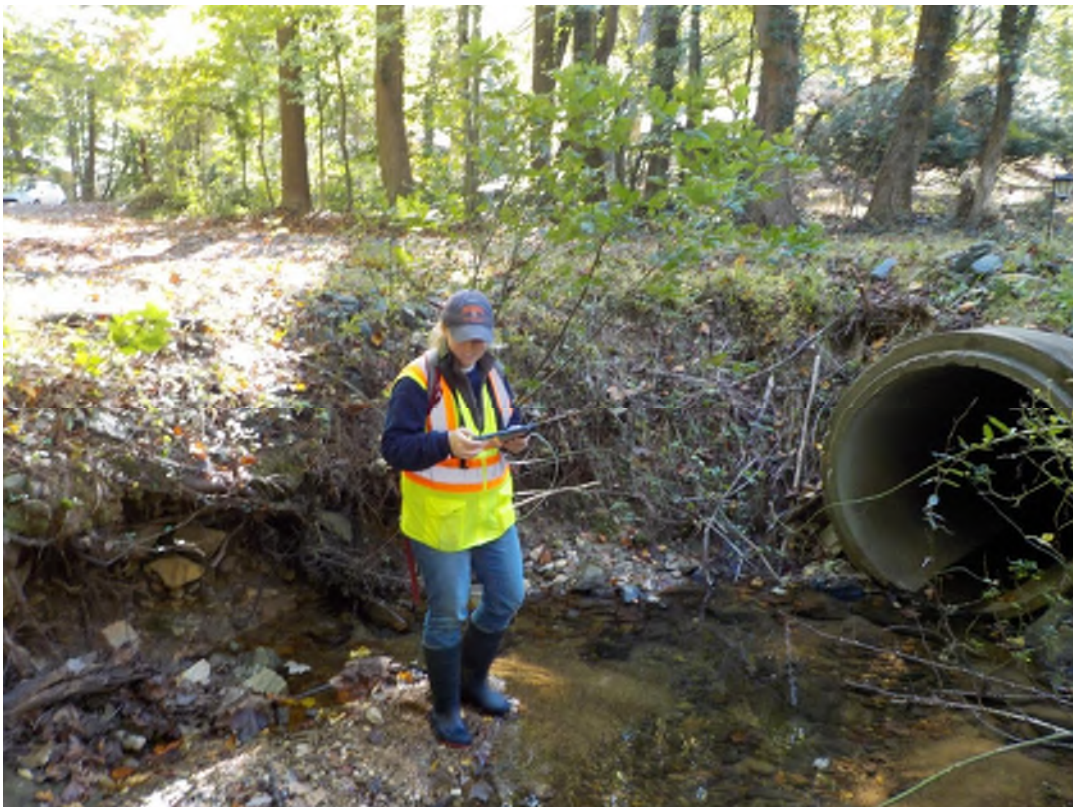
Figure 14: Culverts used to convey flow under driveways in tributary 1. Erosion occurring on banks adjacent to culverts.

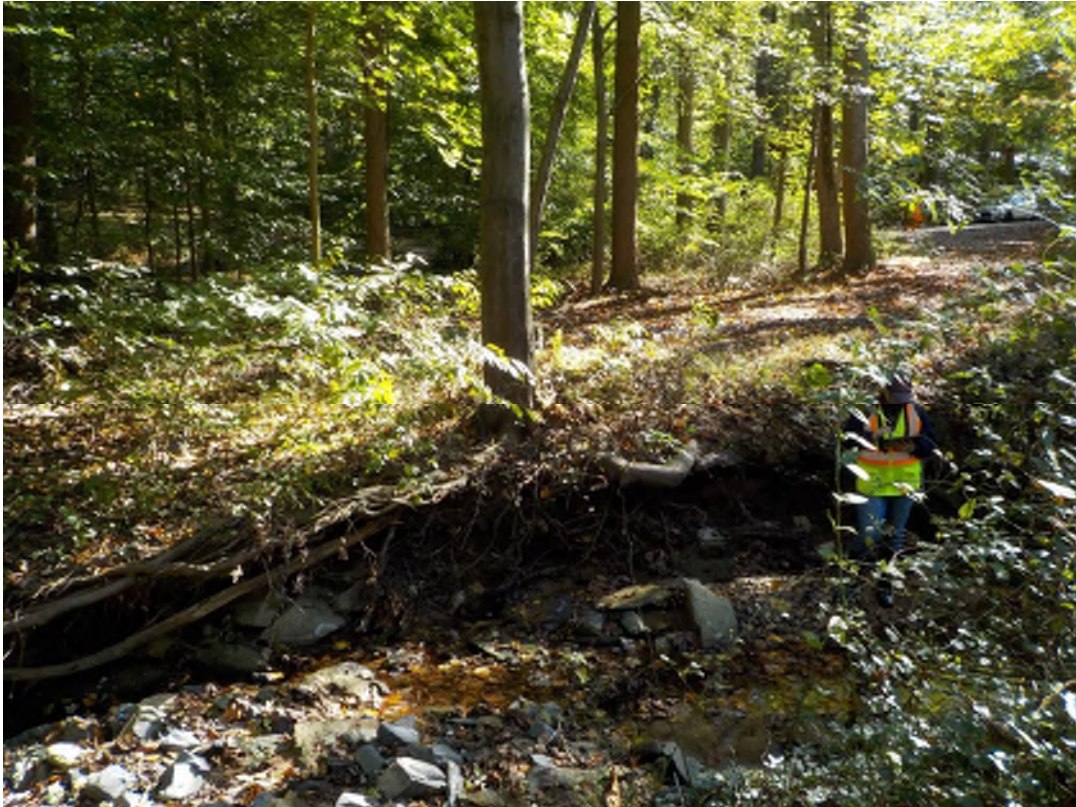
Figure 15: Erosion and undercutting present in tributary 1 prior to confluence of Macphail subwatershed with Victory and Grosvenor subwatersheds.

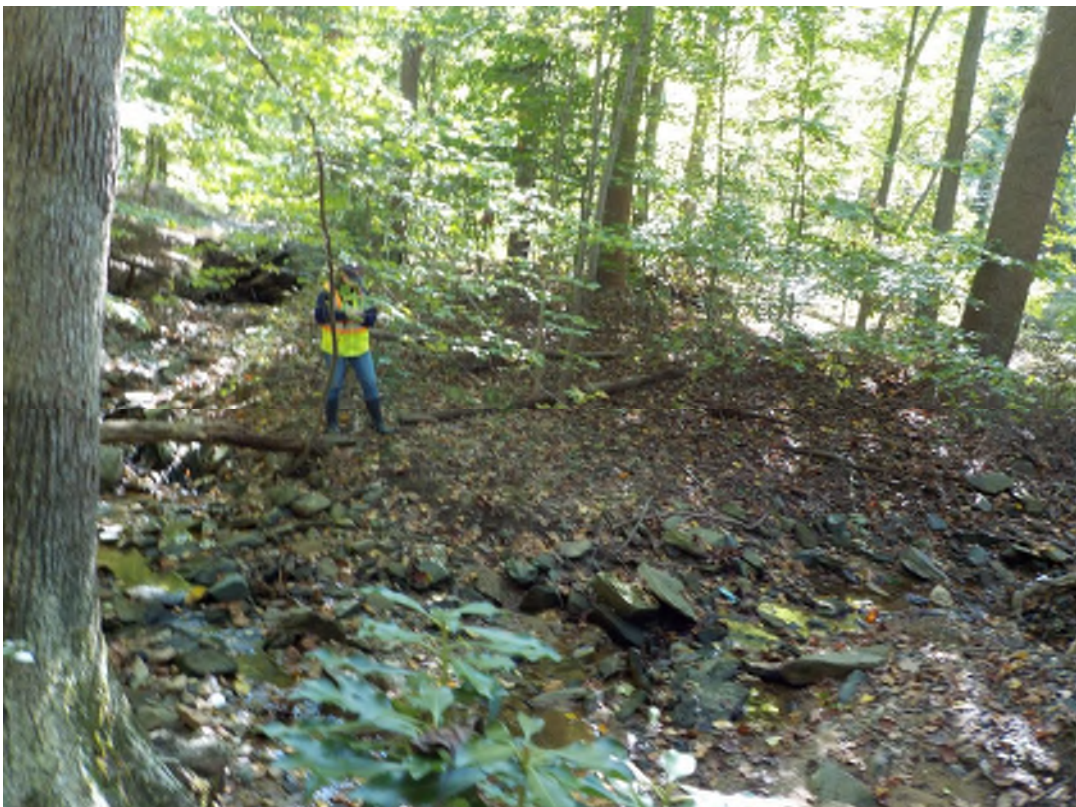
Figure 16: Confluence of Macphail subwatershed (right) with Victory subwatershed (left) at entrance to Grosvenor subwatershed.

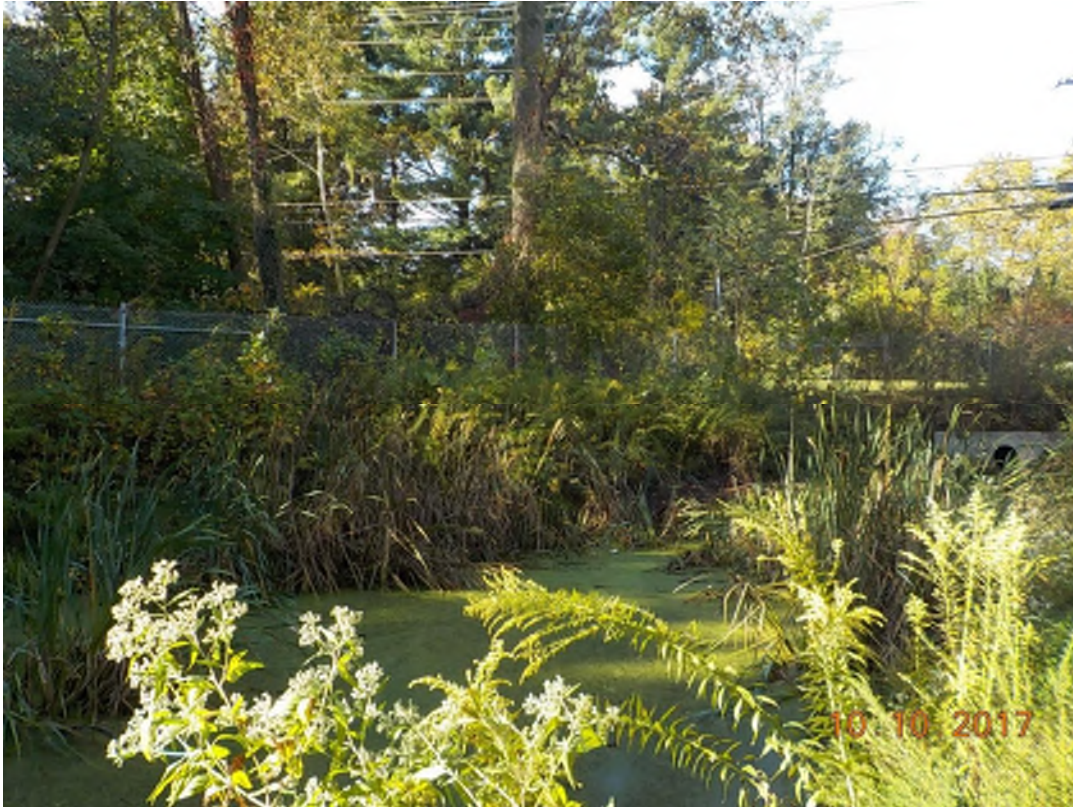
Figure 1: Existing BMP 10 is a wet pond located adjacent to South Main Street and outfall 12. Flow is conveyed from South Main Street to the existing SHA facility. Flow exits facility at outfall 38 (Figure 3).

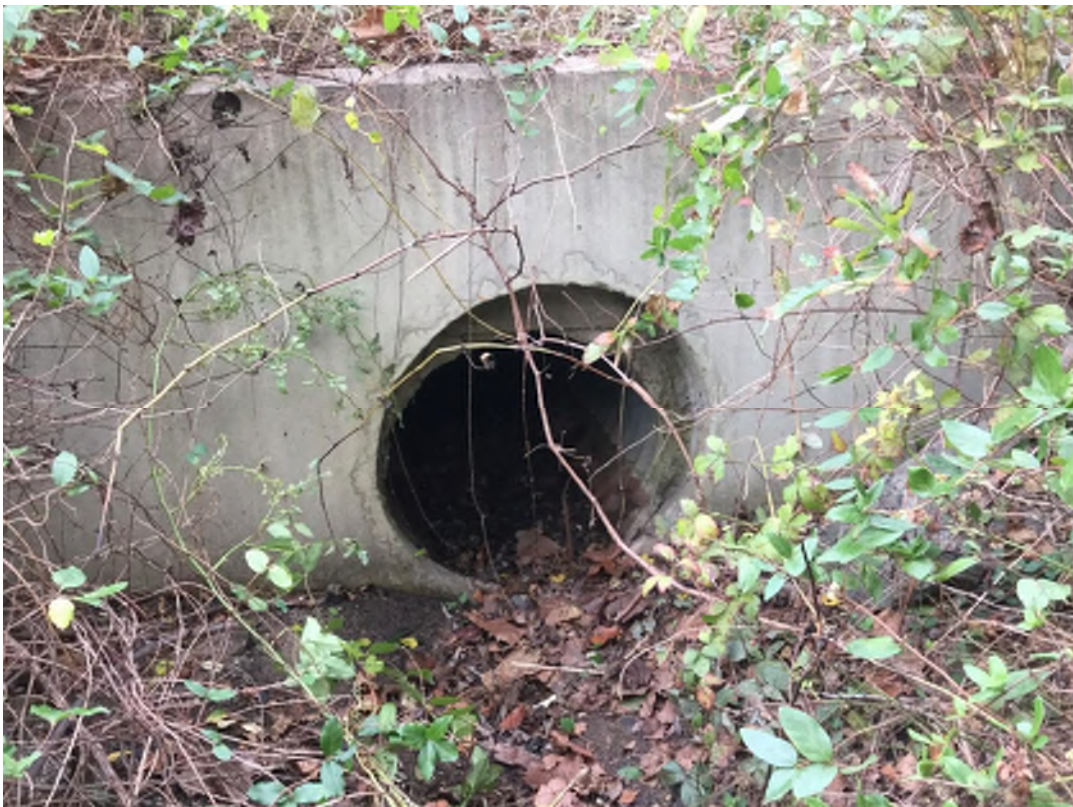
Figure 2: Outfall 12 is a 30" metal pipe at headwaters of Victory subwatershed tributary 1. The outfall collects runoff from the roadway and neighborhood.
